## QUALITY TEST CERTIFICATE

Test report No. 10995.02 / 14

Certification of the degrees of protection IPX6 and the corrosive resistance for the **incremental encoder HOG165C DN 1024 I** under defined environmental conditions, according to the specifications of the standards and to the demands of the client.

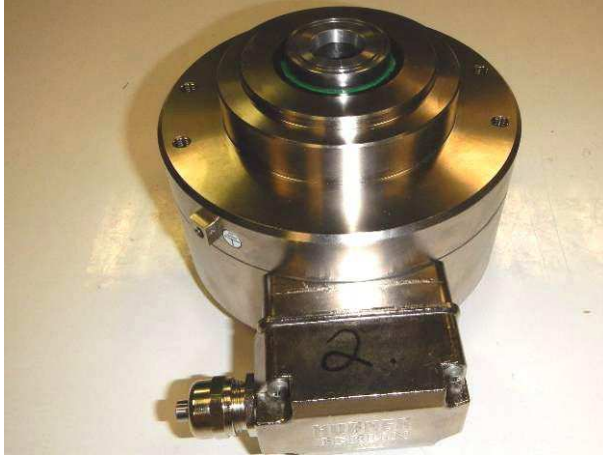
**Picture 1**  
Incremental encoder HOG165C DN 1024 I  
delivery status  
*before the protection against water jets test IPX6*

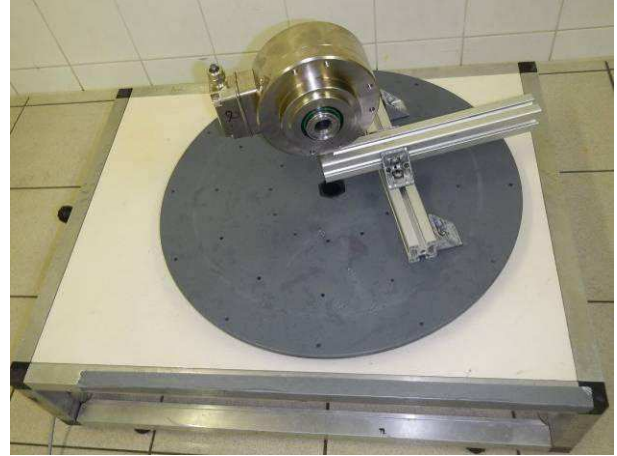
**Picture 2**  
Incremental encoder HOG165C DN 1024 I  
mounted on the turn table  
*before the protection against water jets test IPX6*

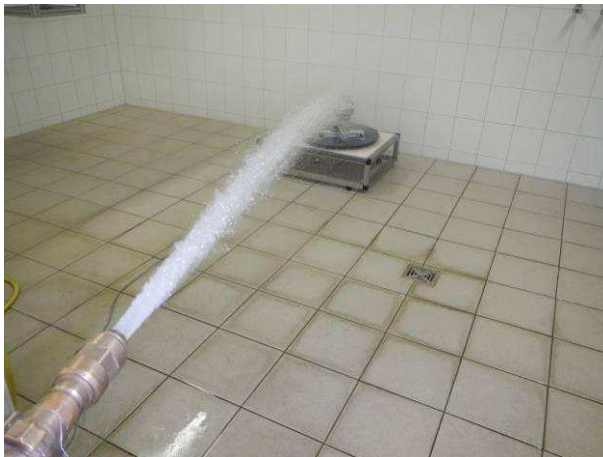
**Picture 3**  
Incremental encoder HOG165C DN 1024 I  
on the turn table with standardized water jet  
*during the protection against water jets test IPX6*

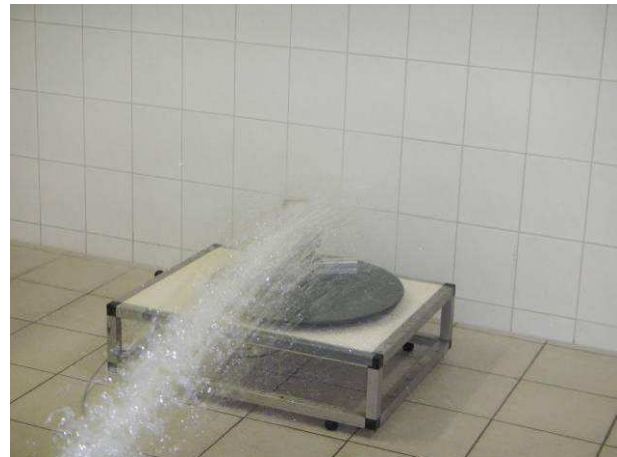
**Picture 4**  
Incremental encoder HOG165C DN 1024 I  
on the turn table with standardized water jet  
*during the protection against water jets test IPX6*

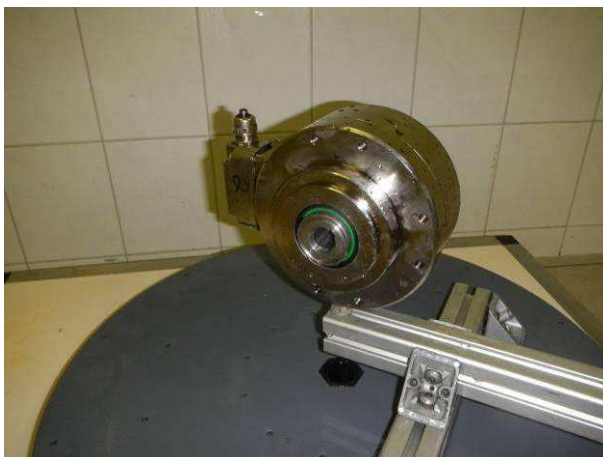
- Without external damage or any other alterations.
- No traces of water was detected inside the specimen.

**Picture 5**  
Incremental encoder HOG165C DN 1024 I  
without any alterations  
*after the protection against water jets test IPX6*

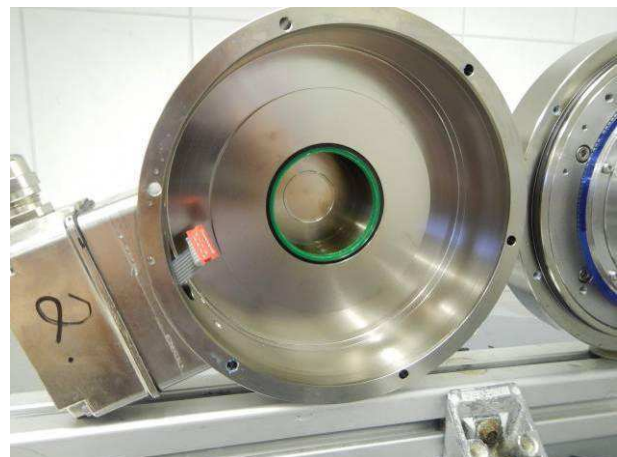
**Picture 6**  
Incremental encoder HOG165C DN 1024 I  
without visible traces of water inside  
*after the protection against water jets test IPX6*

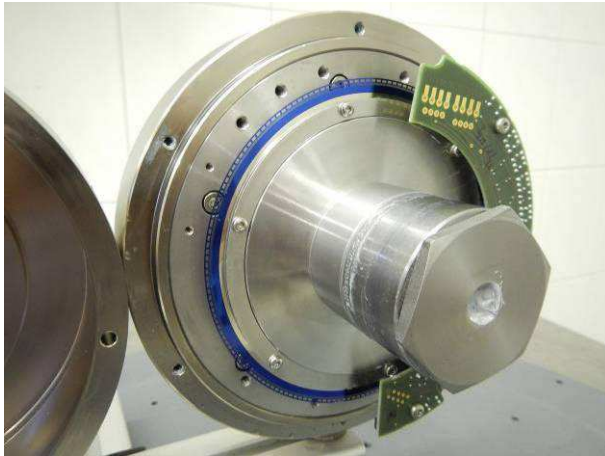
**Picture 7**  
Incremental encoder HOG165C DN 1024 I  
without visible traces of water inside  
after the protection against water jets test IPX6

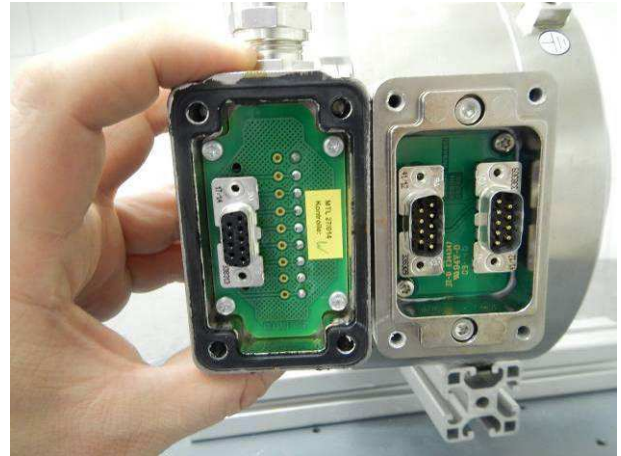
**Picture 8**  
Incremental encoder HOG165C DN 1024 I  
without visible traces of water inside  
after the protection against water jets test IPX6

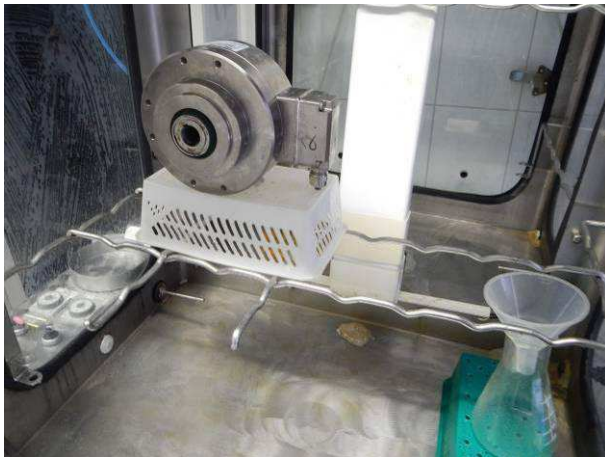
**Picture 9**  
Incremental encoder HOG165C DN 1024 I  
in the salt mist chamber 47  
before the salt mist Kb

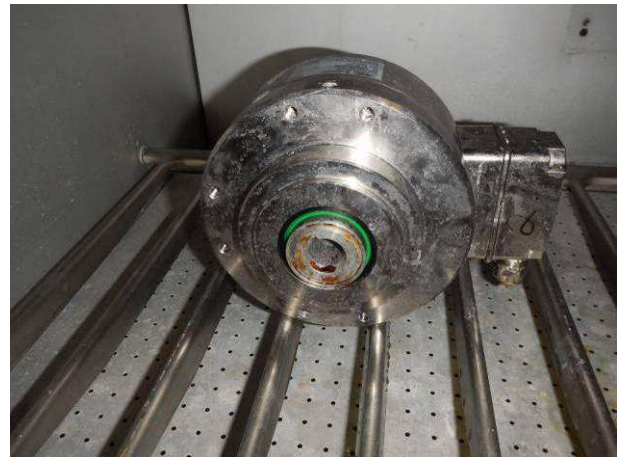
**Picture 10**  
Incremental encoder HOG165C DN 1024 I  
in the climatic chamber 3  
during the salt mist Kb

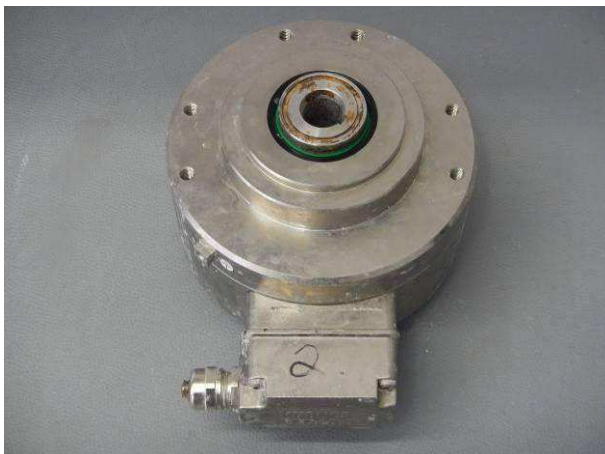
- Corrosive alterations were determined.
- Red rust was detected on the bearing.
- Dark spots and white deposits were detected on the surface of the specimen.

**Picture 11**  
Incremental encoder HOG165C DN 1024 I  
with visible corrosive alterations  
after the salt mist Kb

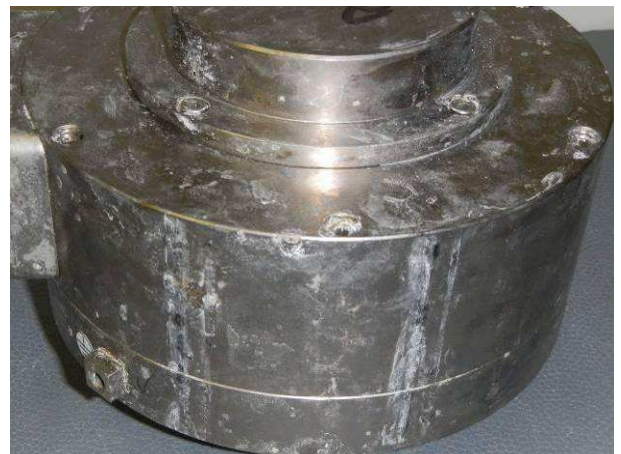
**Picture 12**  
Incremental encoder HOG165C DN 1024 I  
with dark spots and white deposits  
after the salt mist Kb

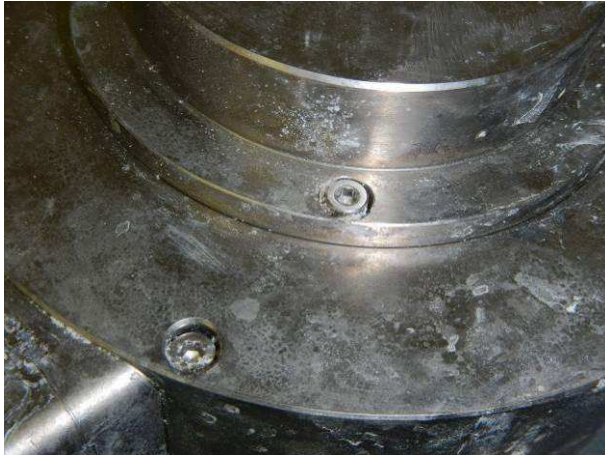
**Picture 13**  
Incremental encoder HOG165C DN 1024 I  
with dark spots and white deposits  
*after the salt mist Kb*

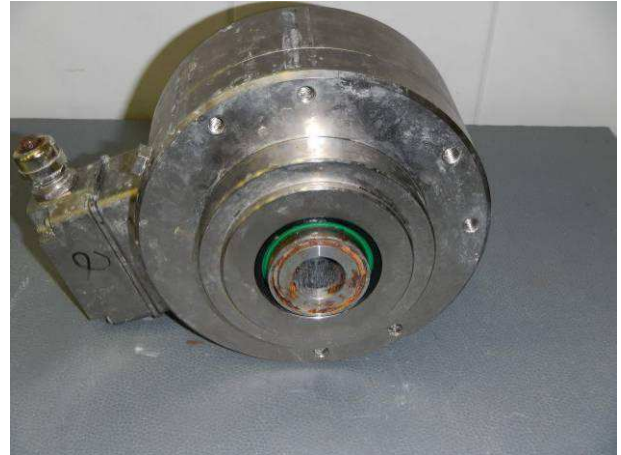
**Picture 14**  
Incremental encoder HOG165C DN 1024 I  
with red rust on the bearing  
*after the salt mist Kb*

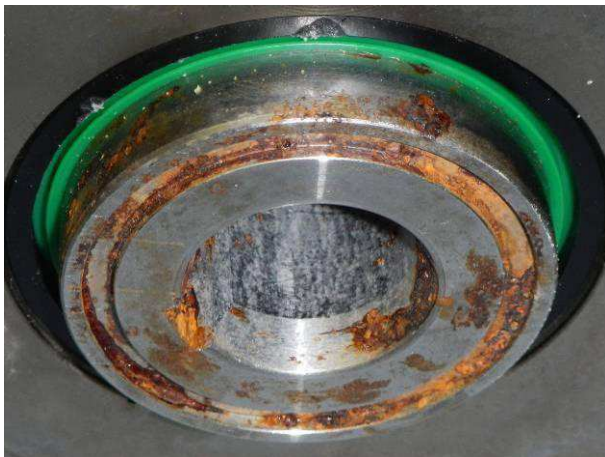
**Picture 15**  
Incremental encoder HOG165C DN 1024 I  
with red rust on the bearing  
*after the salt mist Kb*

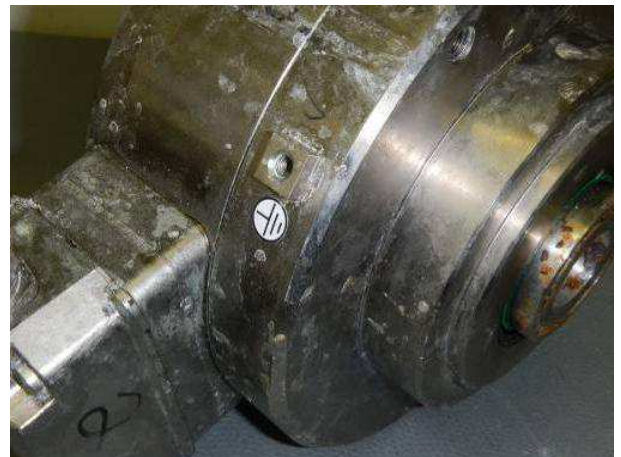
**Picture 16**  
Incremental encoder HOG165C DN 1024 I  
with visible corrosive alterations  
*after the salt mist Kb*
