QUALITY TEST CERTIFICATE

Test report No. 10995.02 / 14

Certification of the degrees of protection IPX6 and the corrosive resistance for the **incremental encoder HOG165C DN 1024 I** under defined environmental conditions, according to the specifications of the standards and to the demands of the client.

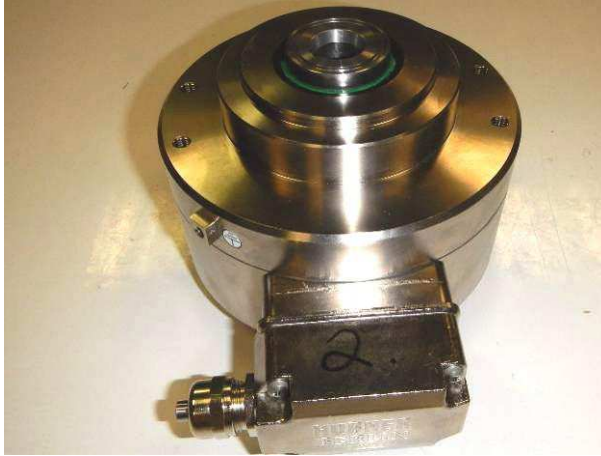
Picture 1
Incremental encoder HOG165C DN 1024 I
delivery status
before the protection against water jets test IPX6

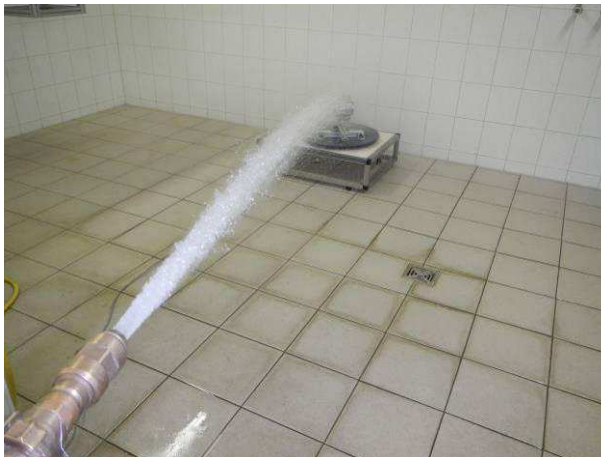
Picture 3
Incremental encoder HOG165C DN 1024 I
on the turn table with standardized water jet
during the protection against water jets test IPX6

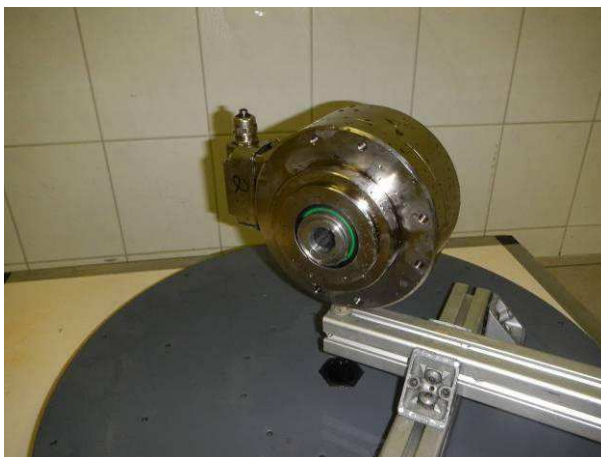
- Without external damage or any other alterations.
- No traces of water was detected inside the specimen.

Picture 5
Incremental encoder HOG165C DN 1024 I
without any alterations
after the protection against water jets test IPX6
