Testing laboratory for climatic, mechanical
and corrosive environmental stress

QUALITY TEST CERTIFICATE

Test report No. 10995.03 / 14

Certification of the degrees of protection IP54 with overpressure for the **incremental encoder HOGS151 DN 5000** under defined environmental conditions, according to the specifications of the standards and to the demands of the client.

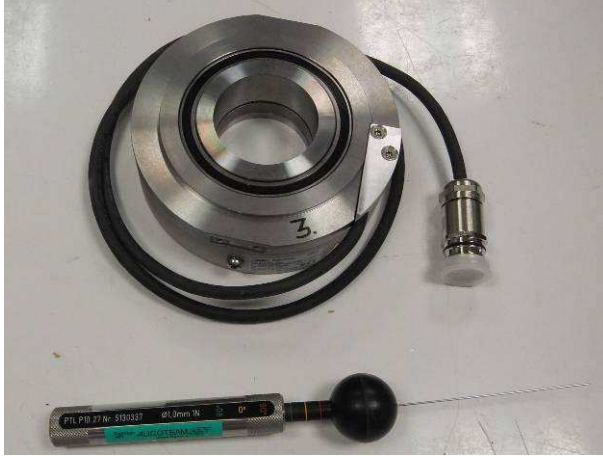
Picture 1
Incremental encoder HOGS151 DN 5000
with standardized test wire (Ø 1 mm, 1 N)
before the access to hazardous parts test IP6X

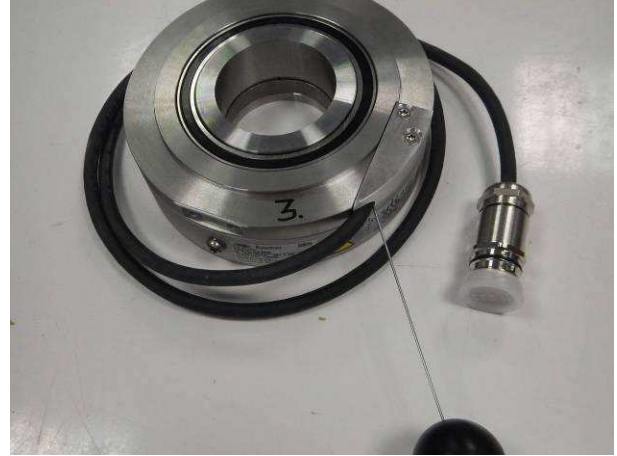
- The test wire could not penetrate the housing.
- No external damage or any other alterations
- No traces of dust was inside the specimen.

Picture 2
Incremental encoder HOGS151 DN 5000
with standardized test wire (Ø 1 mm, 1 N)
during the access to hazardous parts test IP6X

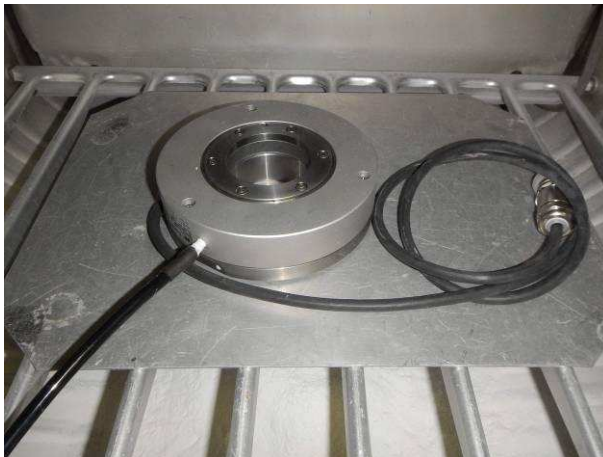
Picture 3
Incremental encoder HOGS151 DN 5000 in the
dust chamber SK 160 with overpressure hose
before the dust test IP6X

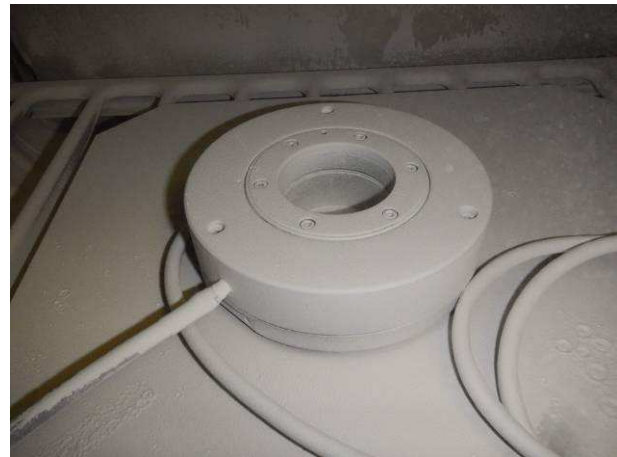
Picture 4
Incremental encoder HOGS151 DN 5000 in the
in the dust chamber SK 160 with overpressure hose
after the dust test IP6X

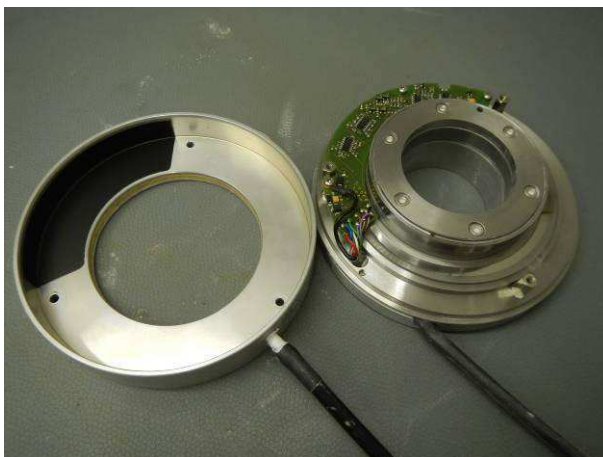
Picture 5
Incremental encoder HOGS151 DN 5000
without visible traces of dust inside
after the dust test IP6X

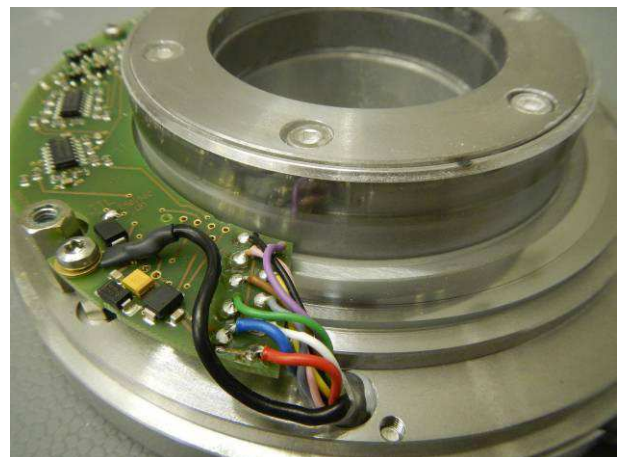
Picture 6
Incremental encoder HOGS151 DN 5000
without visible traces of dust inside
after the dust test IP6X

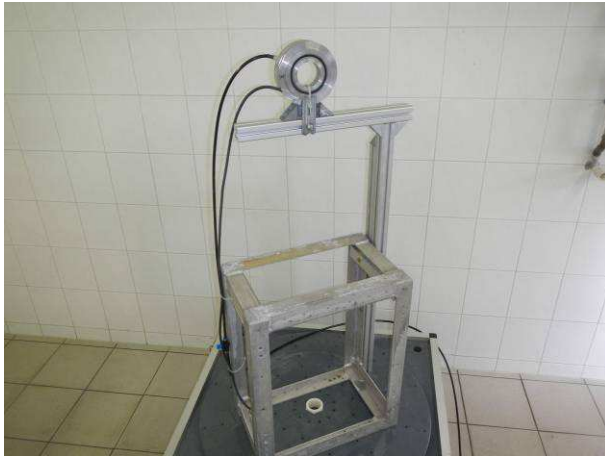
Picture 7
Incremental encoder HOGS151 DN 5000
mounted on the turn table
before the protection against splash water test IPX4

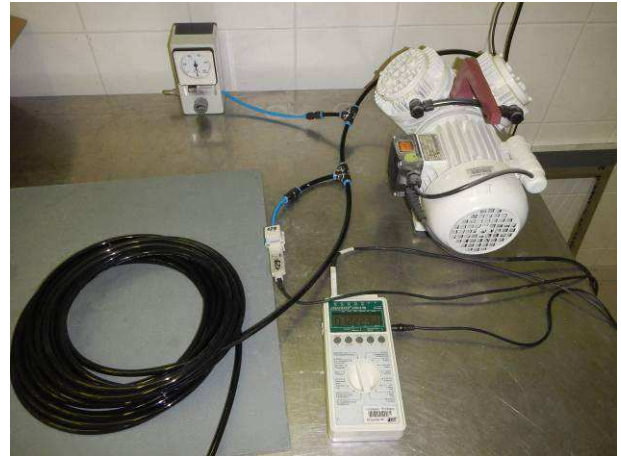
Picture 8
Incremental encoder HOGS151 DN 5000
with equipment for overpressure regulation
before the protection against splash water test IPX4

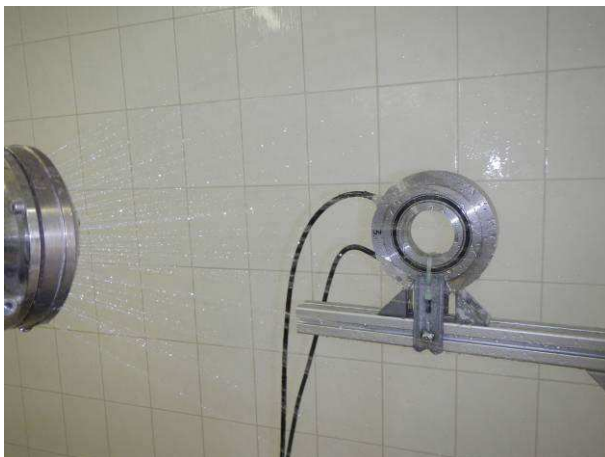
Picture 9
Incremental encoder HOGS151 DN 5000
with standardized splash water
during the protection against splash water test IPX4

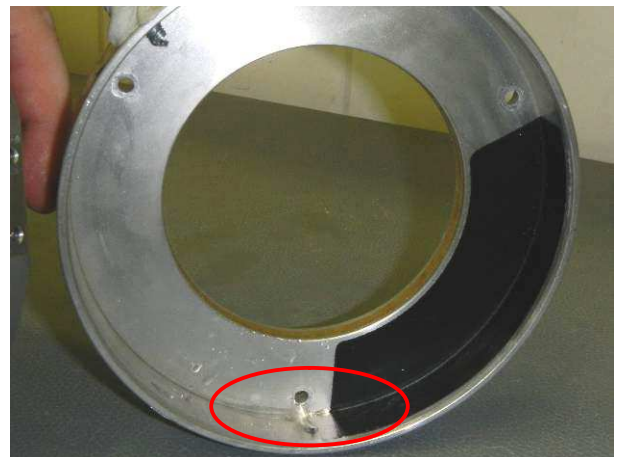
- Without external damage or any other alterations.
- Traces of water were detected inside the housing of the specimen.
- Circuit board without traces of water.
- The client estimates the determined water inside the housing as non-critical.
The degrees of protection IP54 was proven.

Picture 10
Incremental encoder HOGS151 DN 5000
with visible traces of water inside the housing
after the protection against splash water test IPX4

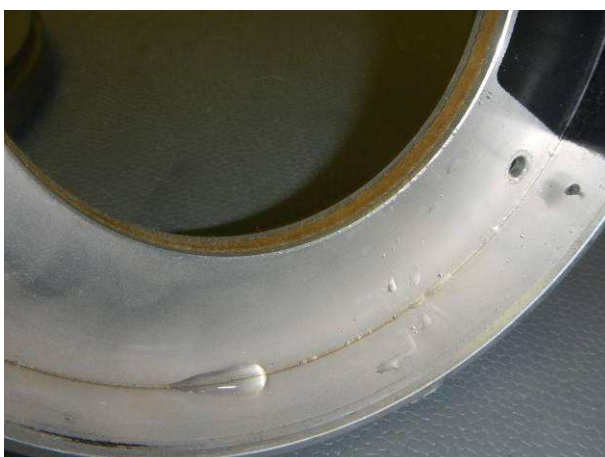
Picture 11
Incremental encoder HOGS151 DN 5000
with visible traces of water inside the housing
after the protection against splash water test IPX4

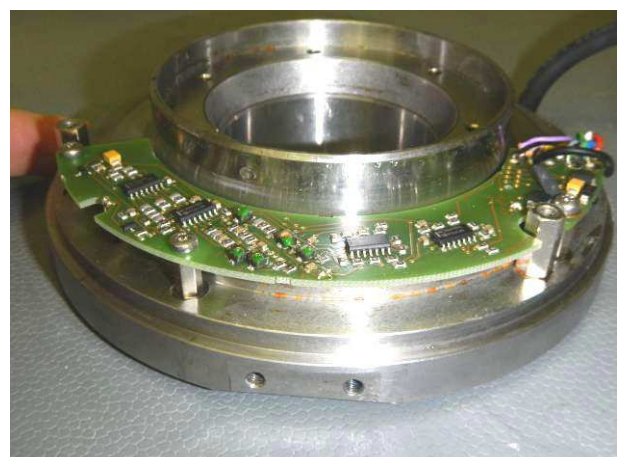
Picture 12
Incremental encoder HOGS151 DN 5000
without visible traces of water on the circuit board
after the protection against splash water test IPX4
