## QUALITY TEST CERTIFICATE

Test report No. 10955.04 / 14

Client	<b>Baumer Hübner GmbH</b> Max-Dohrn-Str. 2+4 10589 Berlin	
Equipment under test	<b>Sensor head</b> Quantity	<b>MHAP XXX</b> 1 unit
Purpose	<b>Tests for the certification of the degrees of protection IP66 and IP67</b>	
Test program	<b>Contact protection test IP6X</b> <b>Immersion substitute test (dust test IP6X)</b> <b>Water jet test IPX6</b> <b>Water diving test IPX7</b>	<i>according to IEC 60529</i> <i>different to IEC 60529</i> <i>according to IEC 60529</i> <i>according to IEC 60529</i>
Test period	29 December 2014 to 28 January 2015	
Execution / results	see pages 2 to 4	
Total number of pages	6 (including 1 appendix)

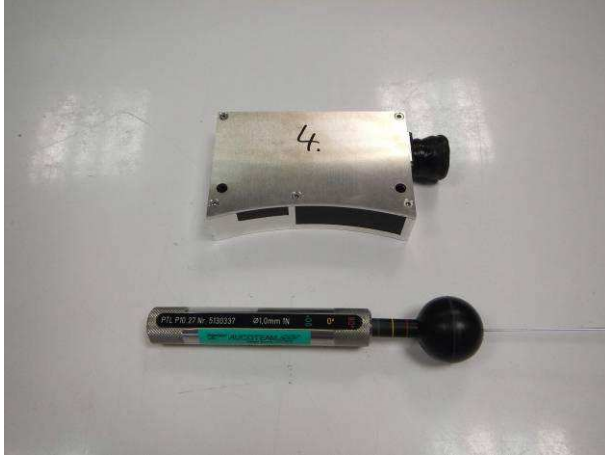
**Picture 1**  
Sensor head MHP XXX  
specimen with rigid steel wire (Ø 1 mm, 1 N)  
*during contact protection test IP6X*

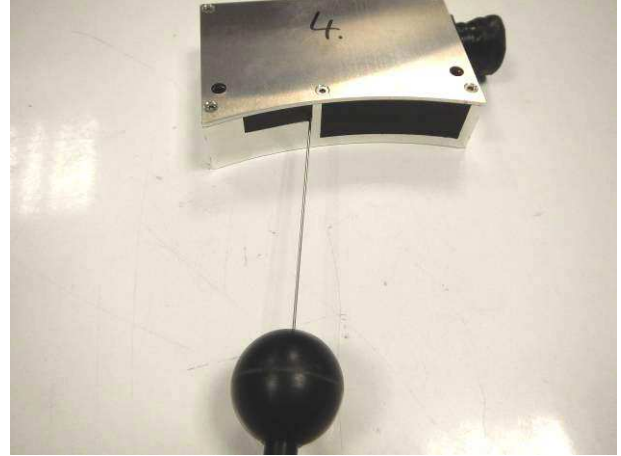
**Picture 2**  
Sensor head MHP XXX  
specimen with rigid steel wire (Ø 1 mm, 1 N)  
*during contact protection test IP6X*

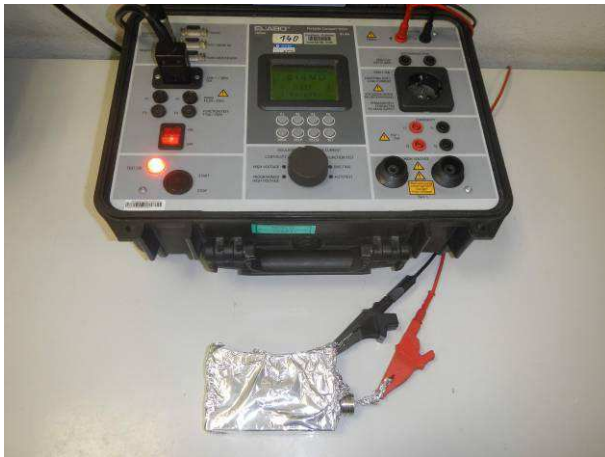
**Picture 3**  
Sensor head MHP XXX  
specimen with portable compact tester  
*insulation test before immersion substitute test IP6X*

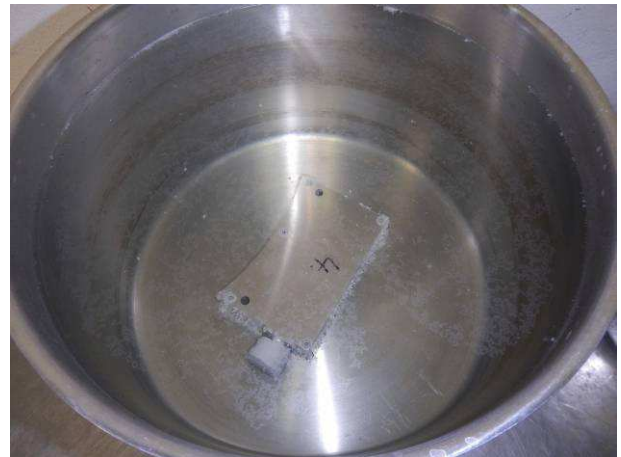
**Picture 4**  
Sensor head MHP XXX  
specimen in the dipping basin 200 mm  
*during the immersion substitute test IP6X*

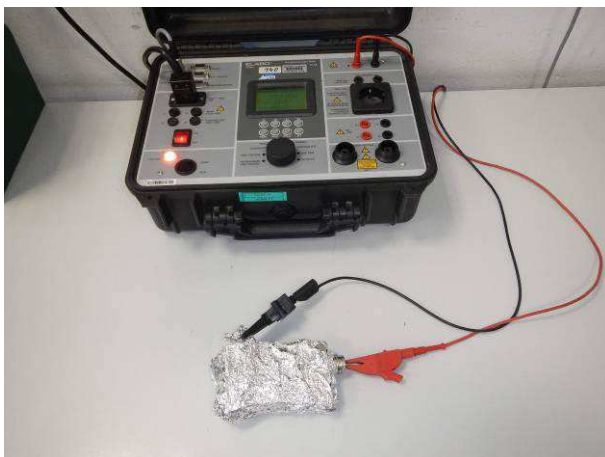
**Picture 5**  
Sensor head MHP XXX  
specimen with portable compact tester  
*insulation test after the immersion substitute test IP6X before the immersion substitute test IP6X*

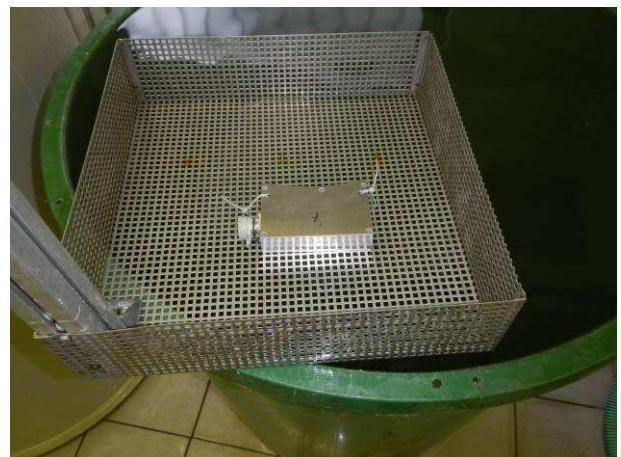
**Picture 6**  
Sensor head MHP XXX  
specimen mounted on the dipping knob  
*insulation test after the immersion substitute test IP6X before the immersion substitute test IP6X*

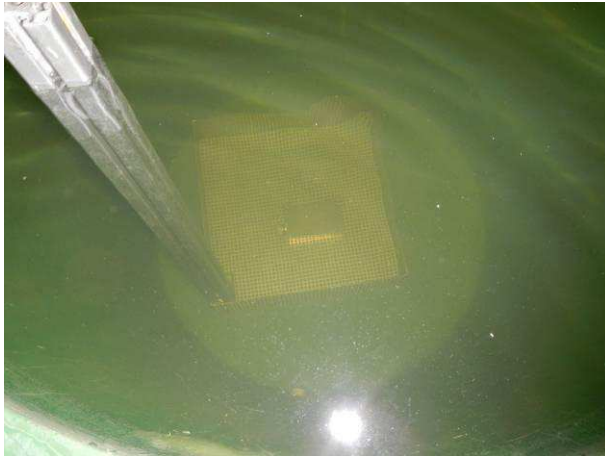
**Picture 7**  
Sensor head MHAP XXX  
specimen in the dipping basin 1000 mm  
during the immersion substitute test IP6X

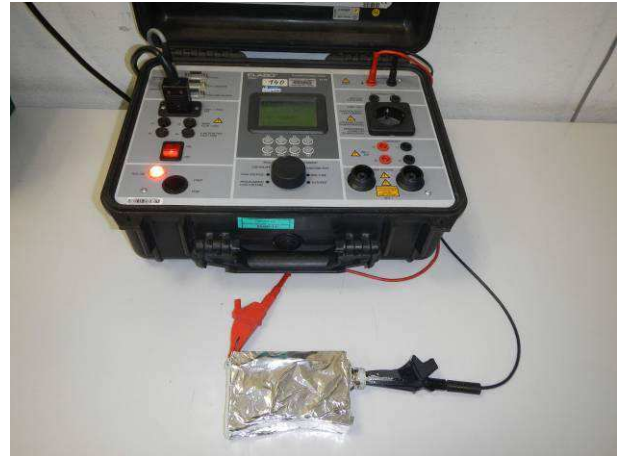
**Picture 8**  
Sensor head MHAP XXX  
specimen with portable compact tester  
insulation test after the water immersion test IPX7

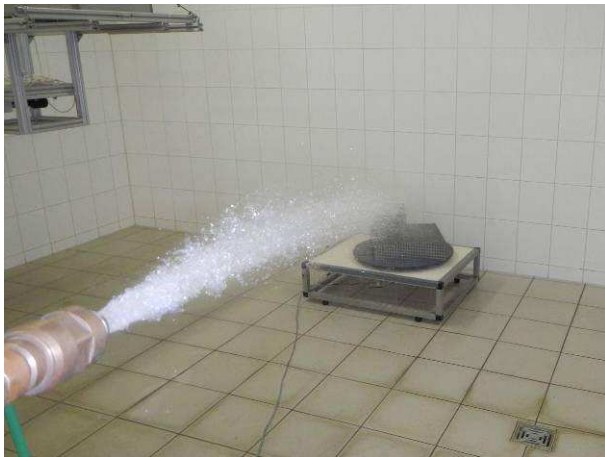
**Picture 9**  
Sensor head MHAP XXX on the  
turn table with water from the spray nozzle  
during the water jet test IPX6

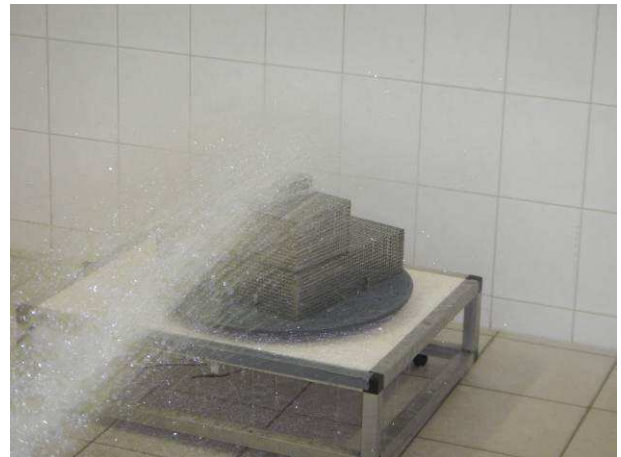
**Picture 10**  
Sensor head MHAP XXX on the  
turn table with water from the spray nozzle  
during the water jet test IPX6

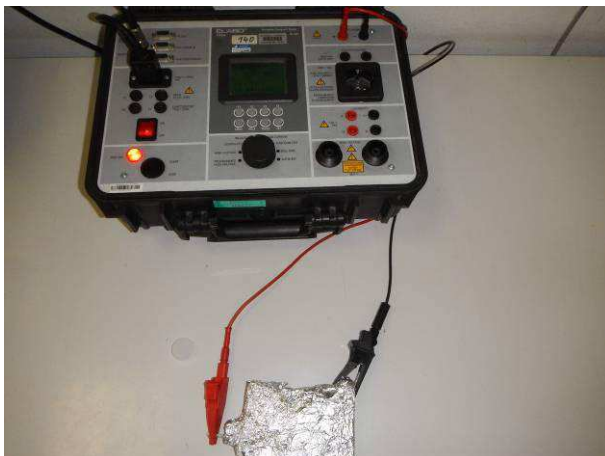
**Picture 11**  
Sensor head MHAP XXX  
specimen with portable compact tester  
insulation test after the water jet test IPX6

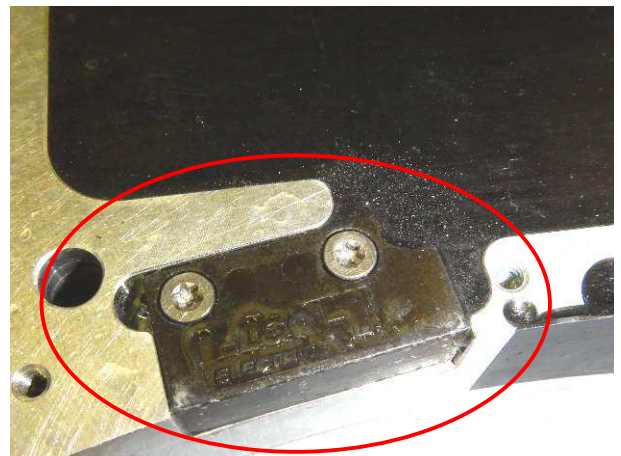
After the 3 protection tests the specimen was opened.

Traces of water on the sealing compound inside the cover were found.

**Picture 12**  
Sensor head MHAP XXX  
traces of water on the sealing compound inside  
after the protection tests IP67 and IPX6
