## CERTIFICATE of QUALITY TEST

### Test report - No. 10996.06 / 14

<b>Client</b>	<b>Baumer Hübner GmbH</b> Max-Dohrn-Str. 2 + 4 10589 Berlin	
<b>Equipment under test</b>	<b>Incremental Encoder</b> 1 sample manufacturing date	<b>POG 10 DN 1024 I</b> SN 700001050793 December 2014
<b>Purpose</b>	<b><i>Test of the dynamic-mechanical robustness under defined environmental conditions</i></b>	
<b>Test program</b>	<b><i>Vibration, sinusoidal 20 g</i></b> <b><i>Shock, half-sine 200 g</i></b>	<i>according to IEC 60068-2-6</i> <i>according to IEC 60068-2-27</i>
<b>Test date</b>	5 January to 21 January 2015	
<b>Realization / results</b>	see page 2 to 3	
<b>Total number of pages</b>	7 (incl. 2 appendices)	
<b>Test result</b>	<b>During and after the tests of the Incremental Encoder POG 10 no external damages were determined. The further evaluation will be done by the client.</b>

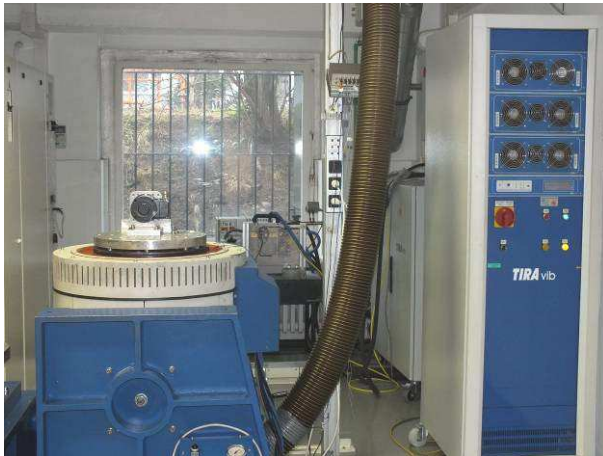
**picture 1**  
Incremental Encoder POG 10  
on the vibration test device  
during vibration test in X-axis

This aluminum fixture with the specimen was directly installed in the respective axis on the vibration / shock table, see pictures in appendix 2

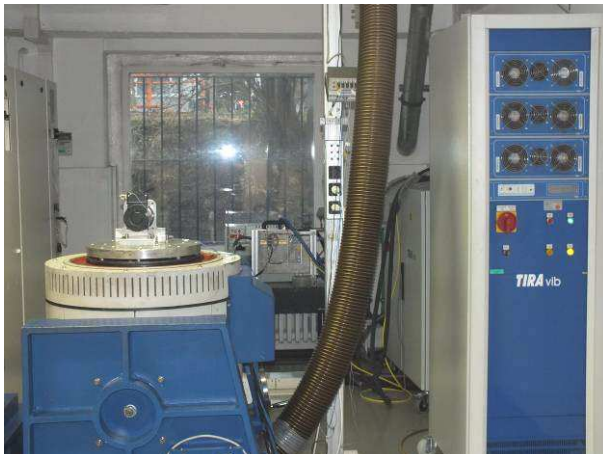
**picture 3**  
Incremental Encoder POG 10  
specimens on the vibration test device  
during vibration test in Y-axis

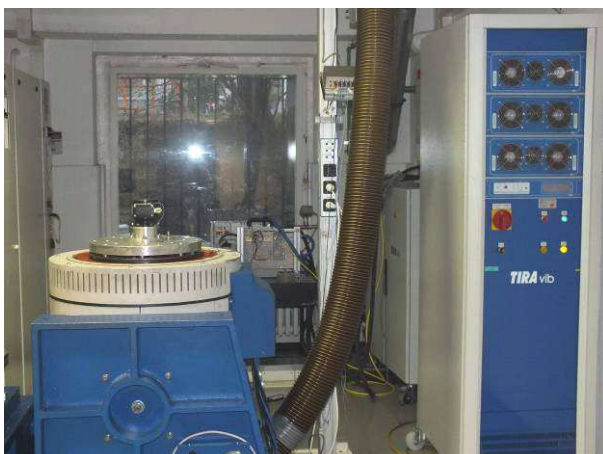
**picture 5**  
Incremental Encoder POG 10  
specimen on the vibration test device  
during vibration test in Z-axis

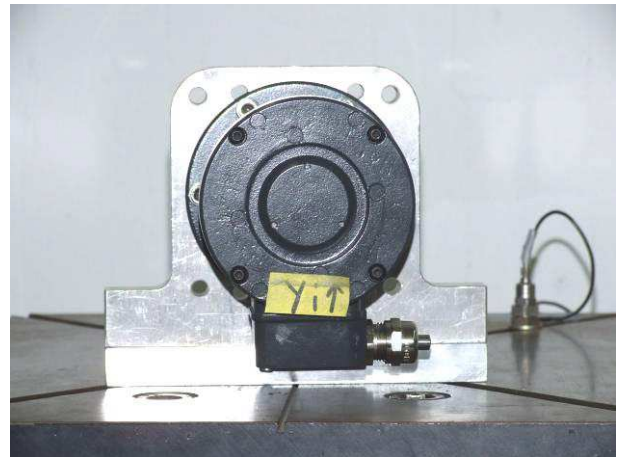
**picture 10**  
**Incremental Encoder POG 10**  
on the shock table with acceleration sensor  
during shock test in Y-axis, negative direction

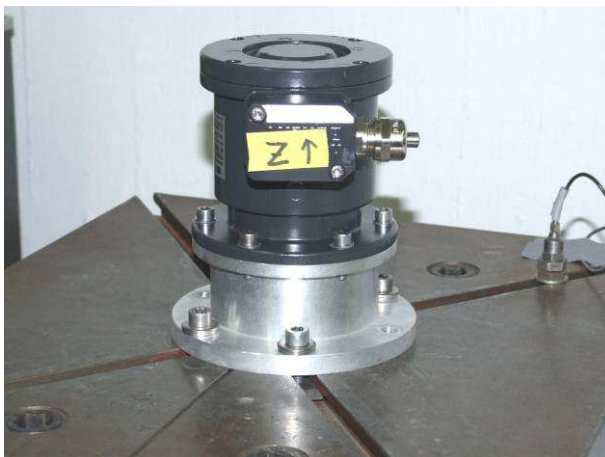
**picture 11**  
**Incremental Encoder POG 10**  
on the shock table with acceleration sensor  
during shock test in Z-axis, positive direction

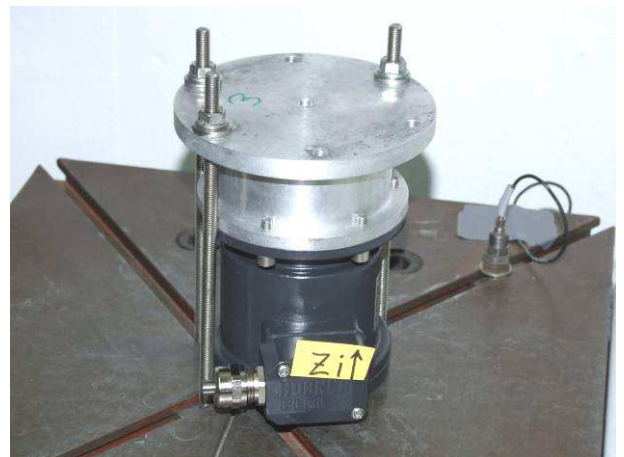
**picture 12**  
**Incremental Encoder POG 10**  
on the shock table with acceleration sensor  
during shock test in Z-axis, negative direction
